Manhole Inspection Summary

Manhole # S43OO_009MH

Location Address: **1601 Normal Ave.**

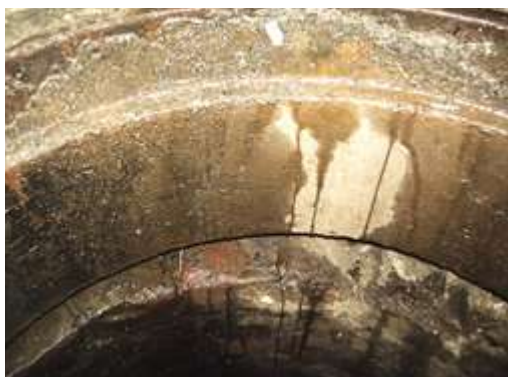
Defect 1

☒ **Leaks**

frame leaks

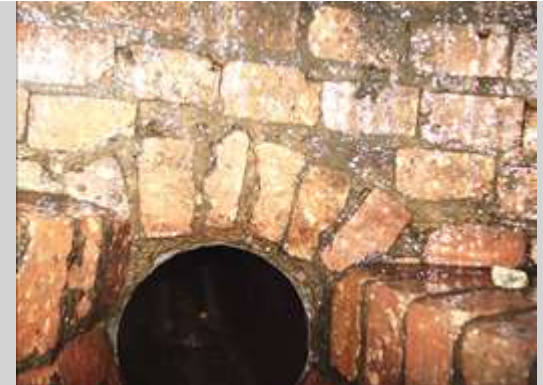
12 O'Clock Outflow

8 in. Circular Gravity Sewer
Pipe Out @ 12 O'Clock

Pipe Height: **14.4** (in.) Rod and Bar (Angled)
Pipe Material: **Clay** ☐ Pipe Lined
Invert Depth: **10.00** (ft.) Flow Characteristics: **Slow**
Deposits: ☒ None ☐ Mud ☐ Sludge ☐ Debris ☐ Grease
Silt Depth: (in.) Deposits Extent:
Infiltration: **None** Pipe Seal Cond: **Sound**

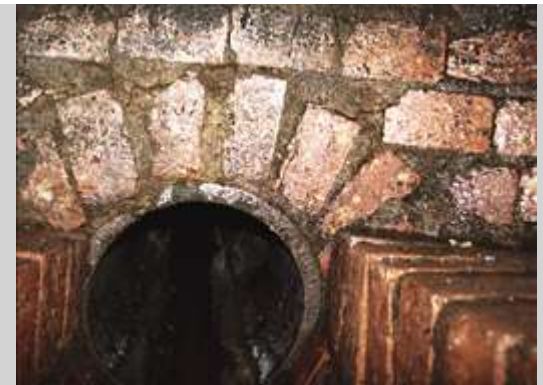
3 O'Clock Inflow

8 in. Circular Gravity Sewer
Pipe In @ 3 O'Clock

Pipe Height: **12** (in.) Rod and Bar (Angled)
Pipe Material: **Clay** ☐ Pipe Lined
Invert Depth: **9.67** (ft.) Flow Characteristics: **Slow**
Deposits: ☒ None ☐ Mud ☐ Sludge ☐ Debris ☐ Grease
Silt Depth: (in.) Deposits Extent:
Infiltration: **None** Pipe Seal Cond: **Sound**

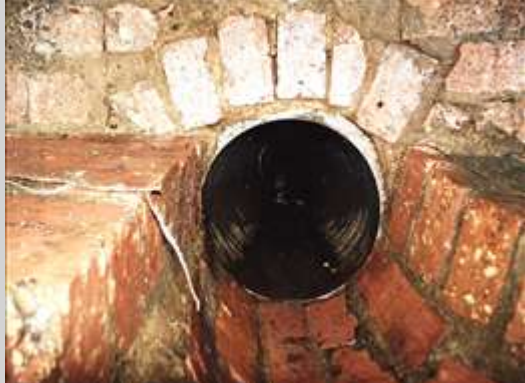
9 O'Clock Inflow

8 in. Circular Gravity Sewer

Pipe Height: **12** (in.) Rod and Bar (Angled)

Infiltration: **None**

Pipe Seal Cond: **Sound**
